**STRUCTURAL SYSTEMS
RESEARCH PROJECT**

Report No.
SSRP - 97/17

**EXPERIMENTAL INVESTIGATION OF
DUCTILITY OF IN-GROUND HINGES IN
SOLID AND HOLLOW PRESTRESSED
PILES**

Final Report on a Research Project funded by Caltrans under
Contract No. DOT 59V375

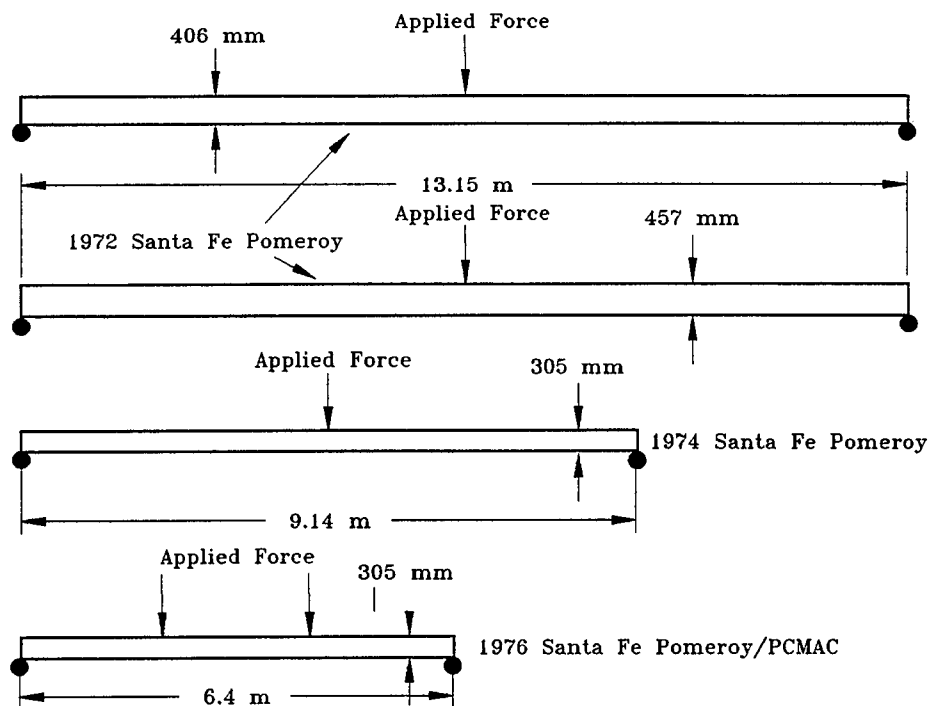
Fig. 2.1: Comparison of spans and loading points of pile tests described by Sheppard (drawings are to true scale)

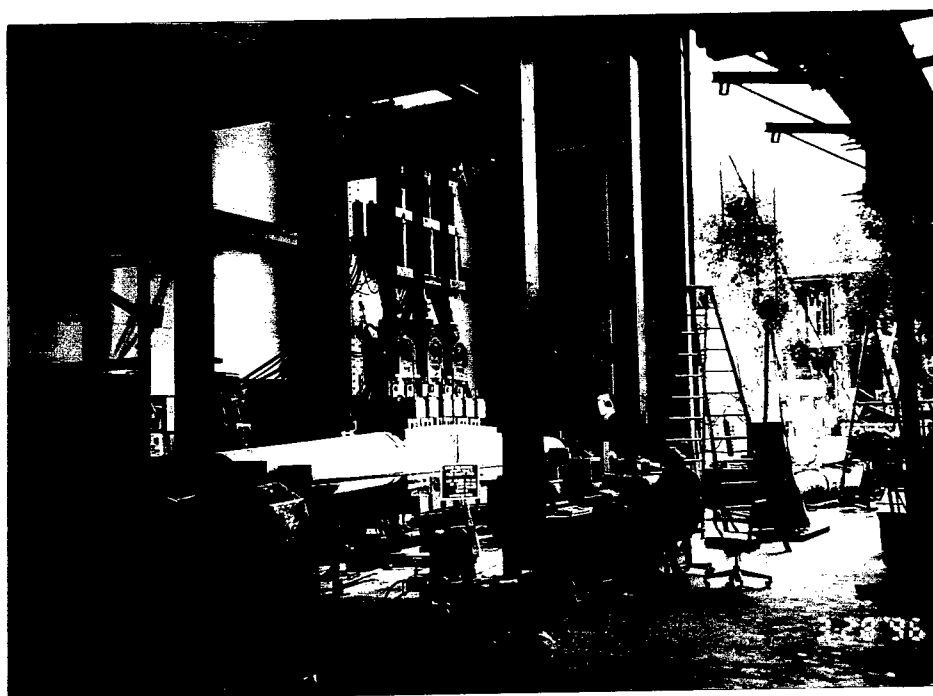
Fig. 3.2: Pile shaft test rig, three-actuator configuration

Fig. 3.2 is a photograph of the test rig, in the three-actuator configuration used for PS9, PS10, PS11, PS14, and PS15. Note the bars carrying the axial load running horizontally across the picture, parallel to the pile shaft.

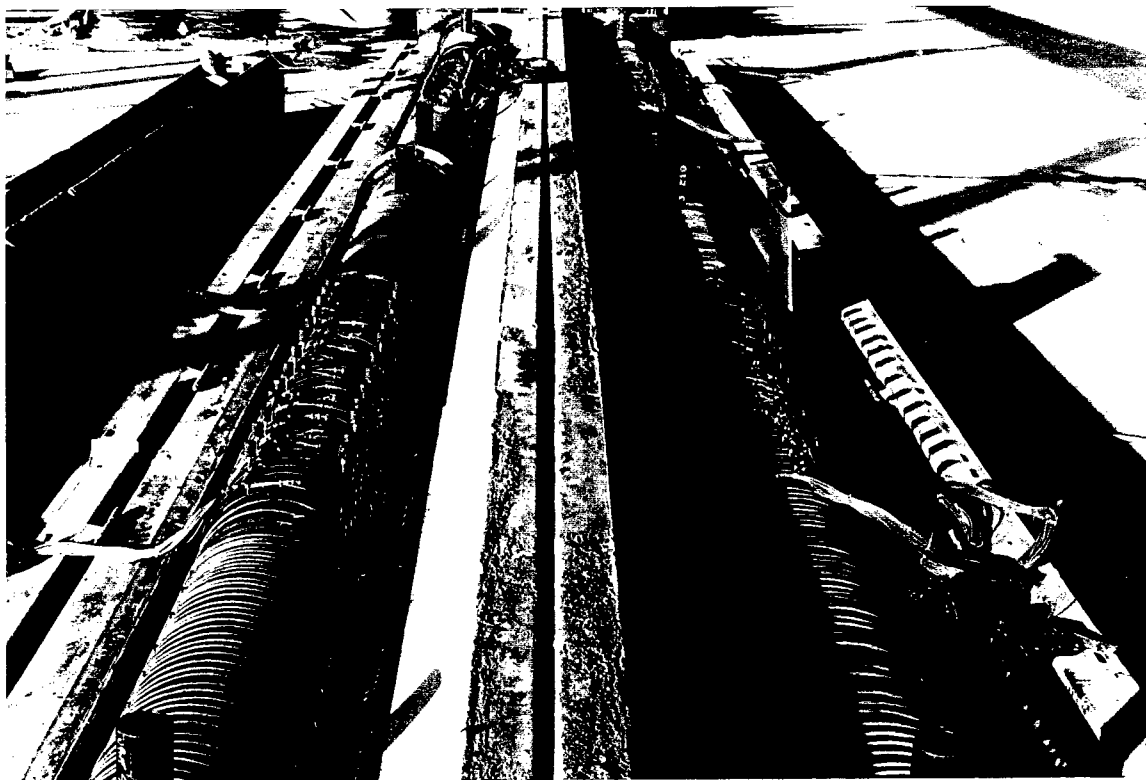
Fig. 3.8: Prestressed piles in casting beds, prior to cast

Shown in figs. 3.8 and 3.9 are steps in the construction of the test piles. The casting beds were steel forms, bolted to a concrete base. The basic forms (which were symmetrical about their long axis and could thus run two sets of tendons) gave the 'bottom' half of the section. Clamshell doors closed over the top of the form (leaving a gap through which concrete could be cast) to give the complete circular section. Stressing bulkheads (drilled with the appropriate tendon pattern) were placed at each end of the assembled forms; the tensioning jack, and the fixed ends of the tendons, reacted against these. Into the forms were first placed movable steel bulkheads (called 'cookies'), drilled for the tendon pattern, which delineated the pile ends (i.e., for a pile of overall length 7.315 m the cookies would be placed that distance apart). In the actual construction of the piles, spiral steel was first placed into the forms, and the tendons then run through one bulkhead, through the first cookie, through the spiral steel, through the second cookie, and out through the terminal bulkhead, where they were secured with chocks (PS7-10 were built two-to-a-side in the forms, so an additional cookie and set of spiral steel was incorporated into the above procedure). The tendons were then given an initial pull of 9 kN, and the spiral stretched out into the proper pitch. The tendons were then given a final pull to bring them up to their desired level of stress, and the spiral tied in place. The forms and doors were oiled, and the doors were then closed over the cages, bolted down, and the concrete cast through the top opening (fig. 3.9). Vibration was by hand-held 'stinger' vibrators and a pneumatic 'vibra-track', a very powerful vibrator that was pulled along tracks running down either side of the form. (The foregoing description is a generic work-flow for precast-prestressed pile construction; instrumentation and

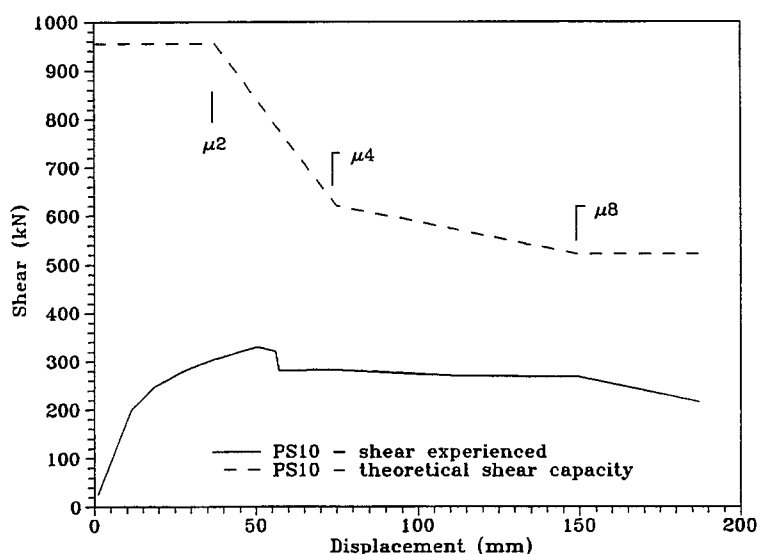
Fig. 3.10: Comparison of theoretical shear capacity with experimentally observed shear, pile shaft test unit PS10

Fig. 3.10 shows a comparison of experimentally observed shear vs. theoretical shear capacity for PS10 (in which the theoretical and response envelopes would have been closest). Clearly shear was not expected to be critical for these piles.

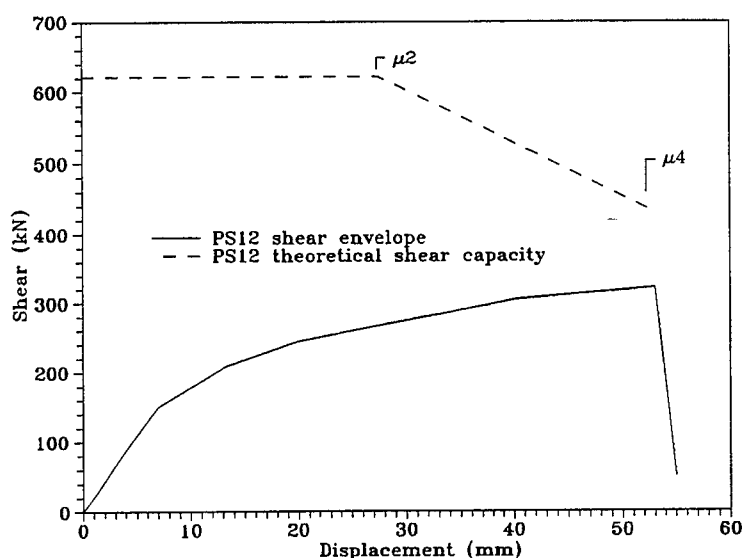
Fig. 3.15 Comparison of theoretical shear capacity with experimentally observed shear,
hollow pile PS12

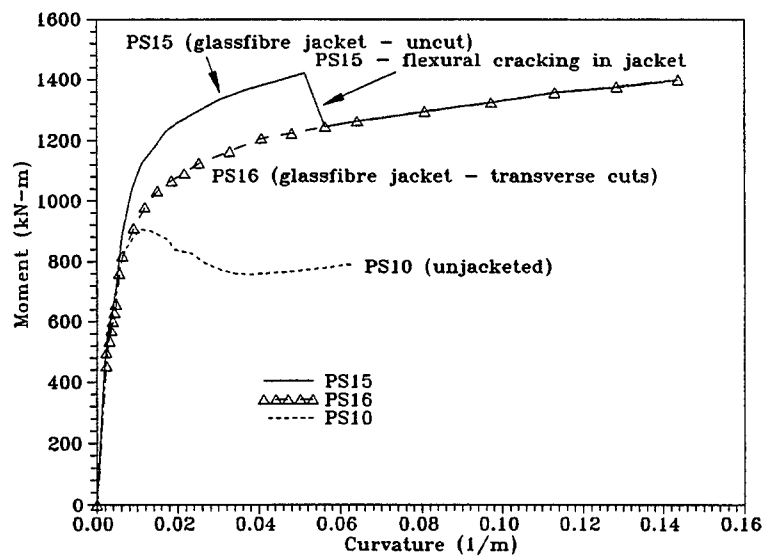
Fig. 3.17: Theoretical moment-curvature data for pile shaft test units PS15 and PS16, using actual material properties (axial load of 890 kN); PS10 (unjacketed) included for reference

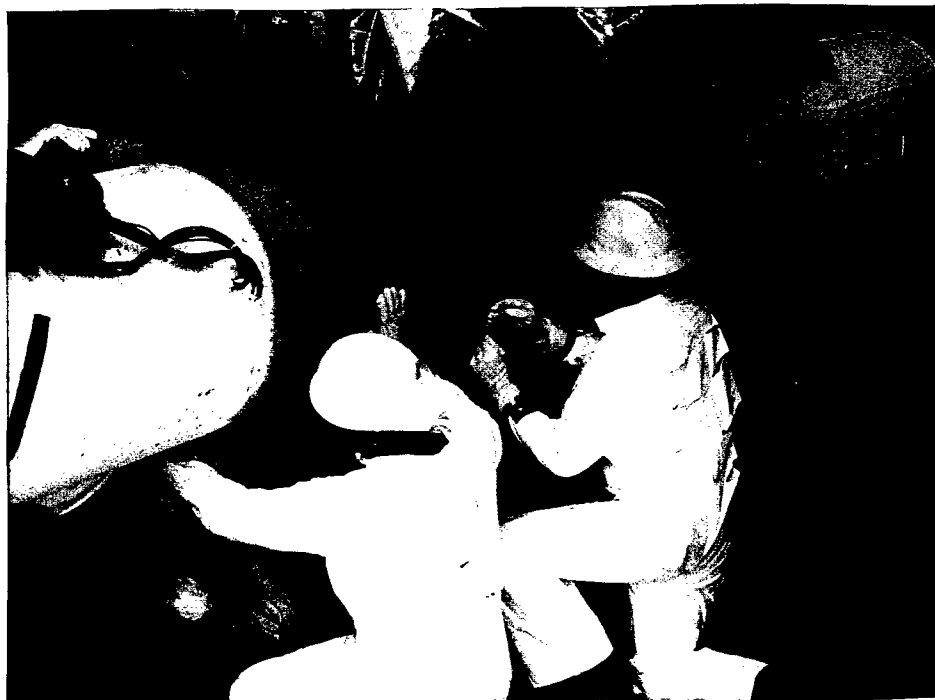
Fig. 3.19: Application of glassfibre wrap to pile shaft test unit PS15

unidirectional E-glass. The main fibers of the E-glass were laid in the transverse direction, as the intention was to provide transverse reinforcement only; additional longitudinal reinforcement was not desired, nor was it desirable. Kevlar™ fibers were used as cross-links in the E-glass uni cloth. Two wraps were used, as per fig. 3.18; the joint was at the center of the pile. This was not expected to have significance, as, again, longitudinal reinforcement was not sought. However, testing of PS15 indicated that the jacket was providing some degree of longitudinal reinforcement which may have degraded the overall performance of the test unit. Therefore, circumferential cuts were made through the jacket of PS16 every 152 mm over a length of 912 mm (centered on the longitudinal midpoint), to force the jacket to provide pure hoop reinforcement in the plastic hinge region (fig. 3.19). Application of the glassfibre wraps is shown in fig. 3.20.

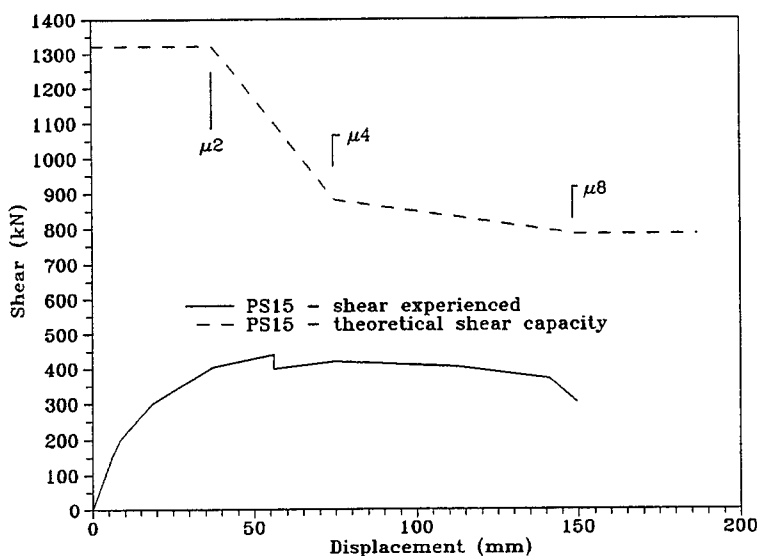
Fig. 3.21: Comparison of theoretical shear capacity with experimentally observed shear, glassfibre-jacketed solid prestressed pile PS15

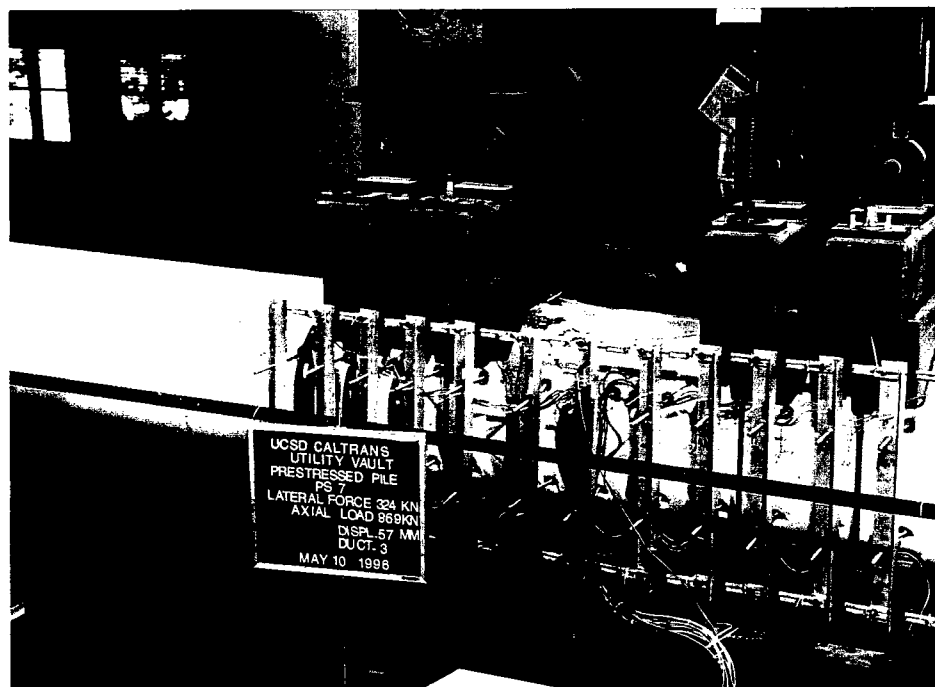
Fig. 5.1.1: Prestressed pile shaft test unit PS7 at $\mu=3$

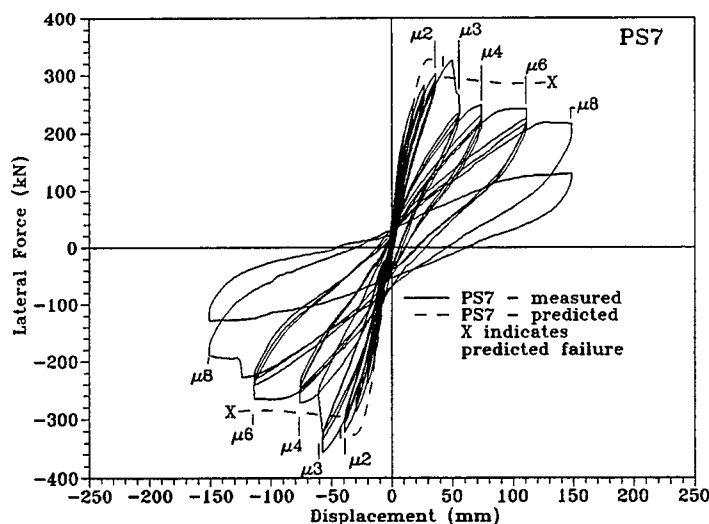
Fig. 5.1.3: Force-displacement hysteresis loops for pile shaft test unit PS7

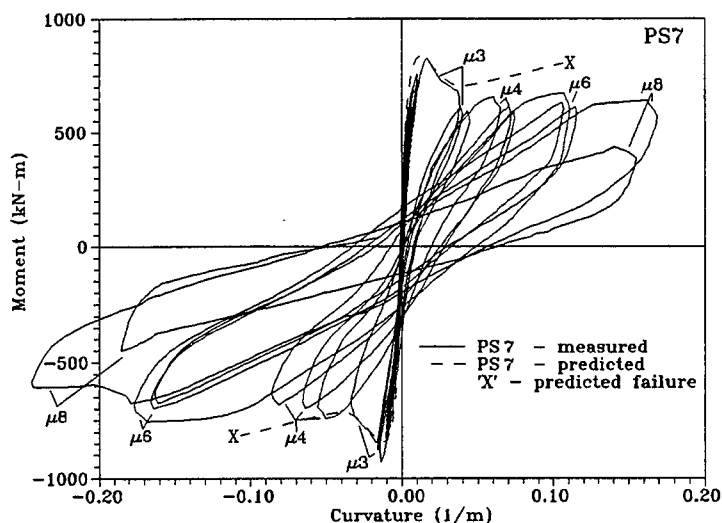
Fig. 5.1.4: Moment-curvature hysteresis loops about the center of prestressed pile shaft test unit PS7

Moment-curvature hysteresis loops appear in fig. 5.1.4, and show good agreement through the point noted by spalling of the cover at $\mu=3$. The post-spalling strength was somewhat lower than predicted, again, probably because of the test fixture concentrating curvature (and thus damage) into a limited area about the pile shaft's longitudinal midpoint (note that the measured critical-section curvature considerably exceeds that which was predicted at high levels of displacement ductility). (It may be noted that the predicted force-displacement response in fig. 5.1.3 takes $p-\Delta$ degradation into account, while the predicted moment-curvature in fig. 5.1.4 does not.)

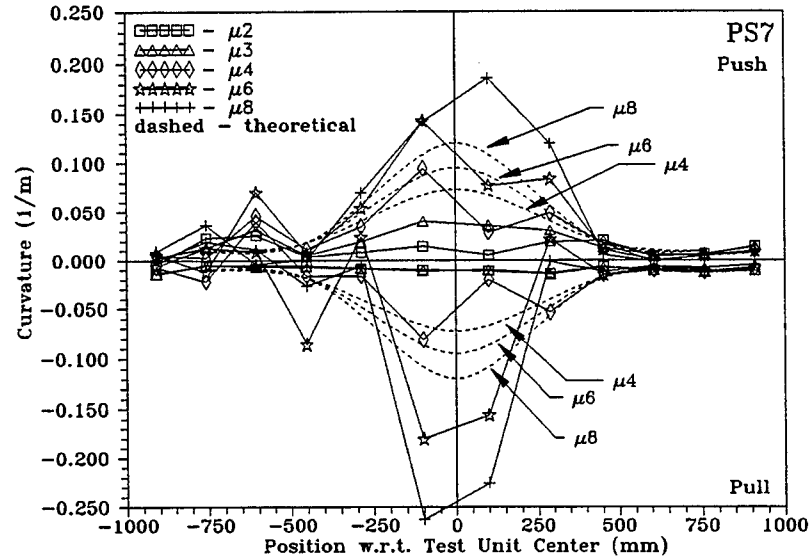
Fig. 5.1.5: Curvature profiles for pile shaft test unit PS7

Curvature profiles for PS7 are shown in fig. 5.1.5. Reasonably good agreement with predicted curvature is evident through lower ductilities up to $\mu=4$, but thereafter there was a concentration of curvature into the center of the test unit, somewhat greater than that which was predicted.

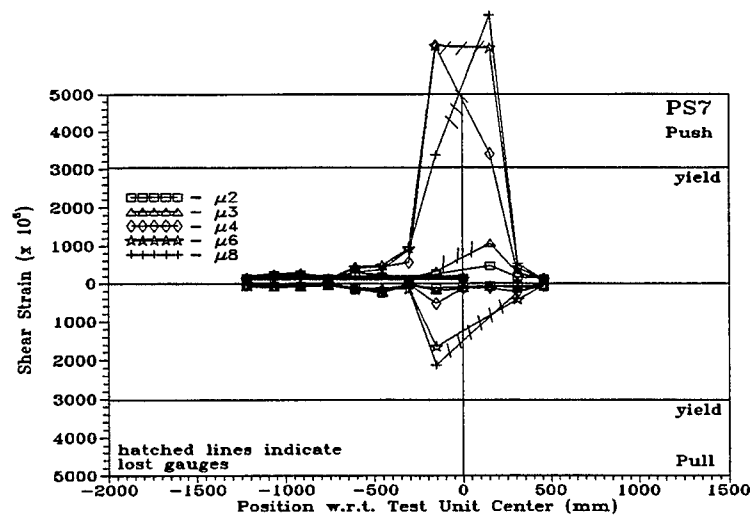
Fig. 5.1.6: Confining steel strain, prestressed pile shaft test unit PS7

Steel strain is shown in the next two figures, 5.1.6 (confining steel strain) and 5.1.7 (shear steel strain). Fig. 5.1.6 illustrates that which was seen in gross examination of the test unit; that is, that there was a significant degree of plasticity in the confining steel (it will be recalled that PS7's ultimate failure was presaged by fracture of confining steel).

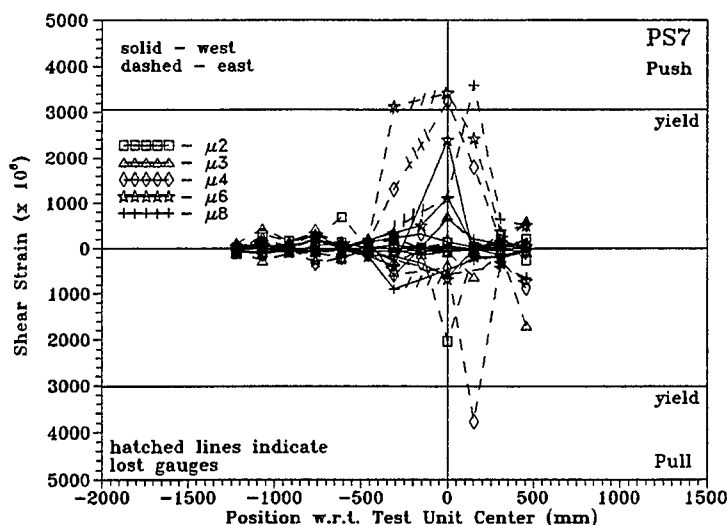
Fig. 5.1.7: Shear steel strain, prestressed pile shaft test unit PS7

Fig. 5.1.7 indicates that some plasticity was occurring at higher ductilities in the shear-resisting steel truss, as damage to the core concrete began to compromise that mechanism, or as confinement-induced strains spread to the horizontal axis.

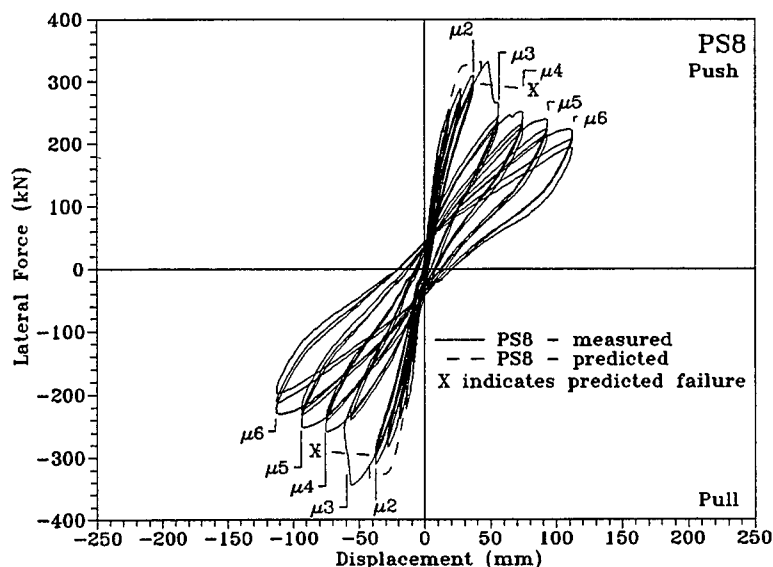
Fig. 5.2.3: Force-displacement hysteresis loops for pile shaft test unit PS8

The force deflection loops for PS8 are shown in fig. 5.2.3. PS8 reached its peak strength just before $\mu=3$, at which point the cover began to spall away, reducing the load-carrying capacity of the section by a significant amount. Repeated cycling at $\mu=3$ and beyond resulted in only a slow degradation of strength.

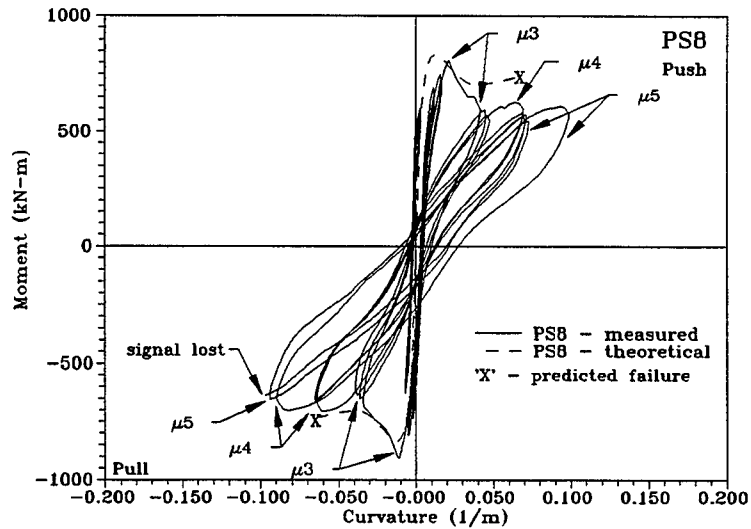
Fig. 5.2.4: Moment-curvature hysteresis loops about longitudinal midpoint, prestressed pile shaft test unit PS8

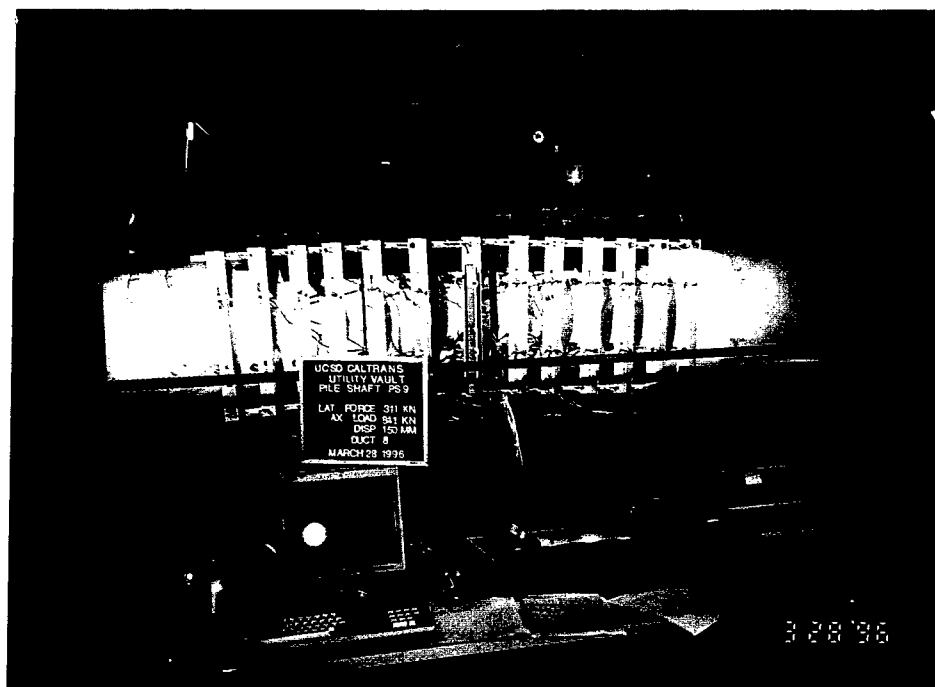
Fig. 5.3.1: Prestressed pile shaft test unit PS9 at $\mu=8$

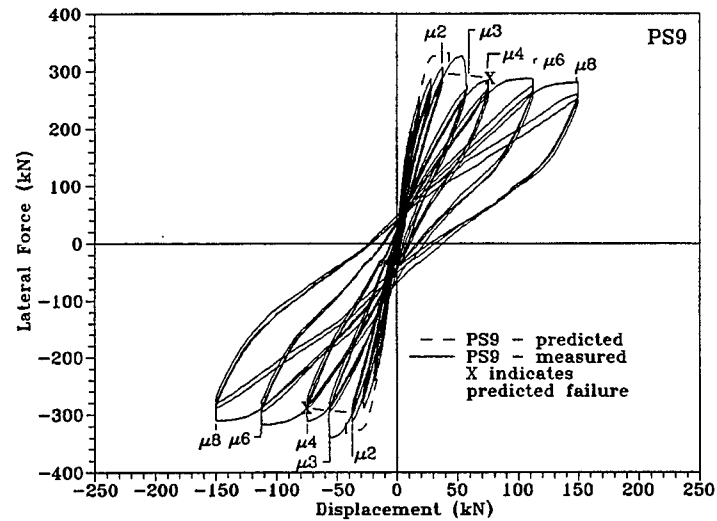
Fig. 5.3.3: Force-displacement hysteresis loops for pile shaft test unit PS9

Predicted force-deflection also appears on fig. 5.3.3. This prediction takes into account the $P-\Delta$ effect. The prediction agreed relatively well with the experimental results in terms of maximum lateral force capacity; however, PS9 showed more ductility capacity than was expected. Peak load occurred at a greater level of displacement ductility than was predicted ($\approx \mu=2.2$ predicted vs. $\mu=3$ actual). Failure was predicted at $\mu \approx 4$, and PS9 was still carrying load at $\mu=8$. As has been noted, neither observation of the specimen during the test nor examination of the data showed evidence that either tendons or transverse steel broke. In contradistinction with units PS7 and PS8, load carrying capacity after initial spalling matched or exceeded (on the pull cycles) theoretical strength, and capacity was maintained until ductilities greatly in excess of predicted ultimate levels.

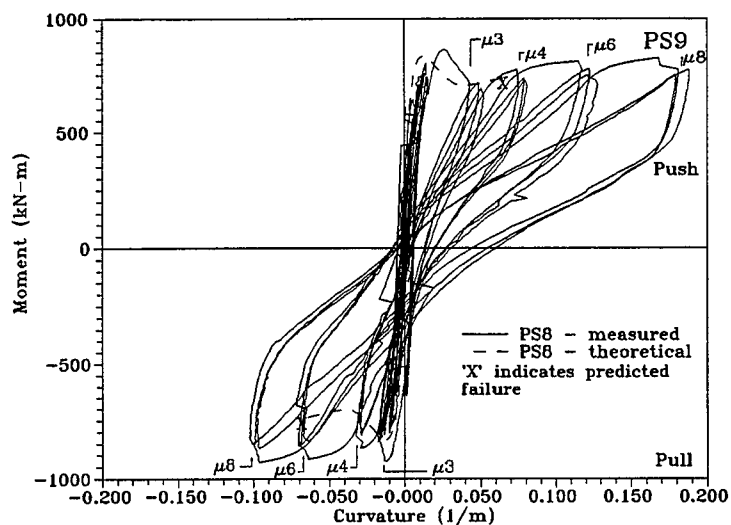
Fig. 5.3.4: Moment-curvature hysteresis loops about test unit midpoint, prestressed pile shaft test unit PS9

Shown in fig. 5.3.4 are moment-curvature hysteresis loops for PS9, taken about the test unit's longitudinal midpoint. Interestingly, greater curvature is seen at high ductilities for the push cycles than for the pull cycles (also to be noted in the curvature profiles of fig. 5.3.5). This is probably because of a slight asymmetry in the pattern of prestressing strand allowing a shallower depth of cover concrete on the bottom of the shaft (i.e., that side which would be in compression during the pull cycles). Evidence to support this is seen in the force-displacement hysteresis loops (fig. 5.3.3), in which the pull-cycle post-spalling strength is somewhat higher than both the prediction, and the push-cycle post-spalling strength.

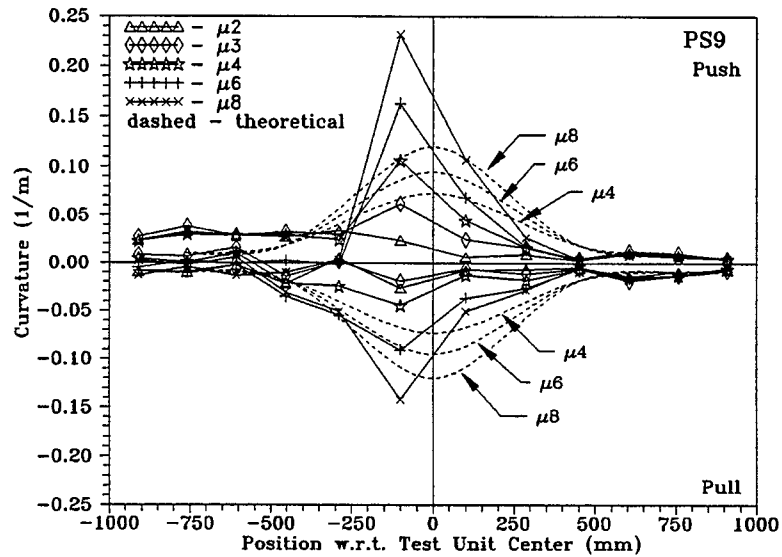
Fig. 5.3.5: Curvature profiles, prestressed pile shaft test unit PS9

Aside from the obvious asymmetry mentioned above, a point of interest in the curvature profiles of fig. 5.3.5 is the good agreement with theory through the earlier (low levels of ductility) part of the test.

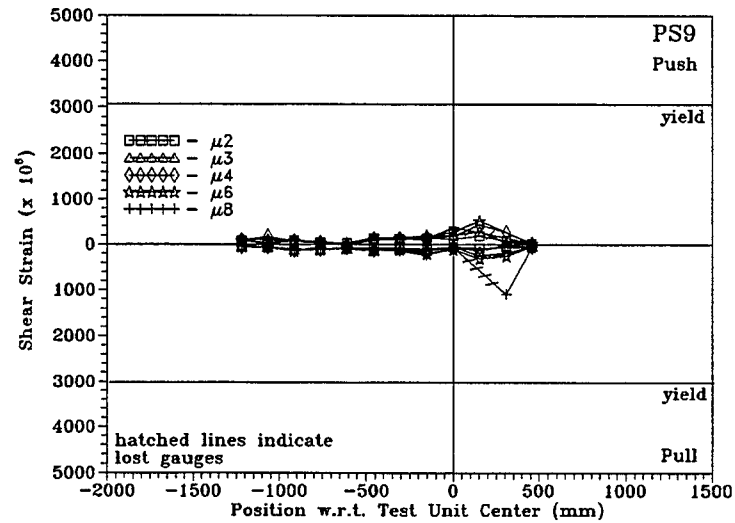
Fig. 5.3.6: Confining steel strains, prestressed pile shaft test unit PS9

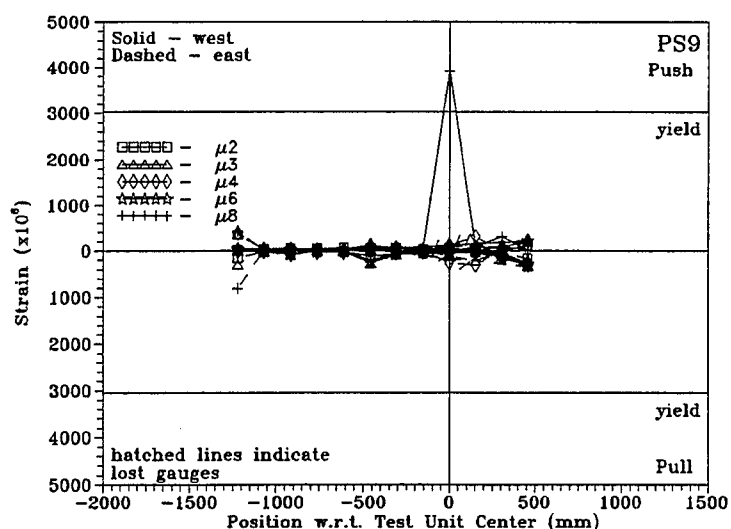
Fig. 5.3.7: Shear steel strains, prestressed pile shaft test unit PS9

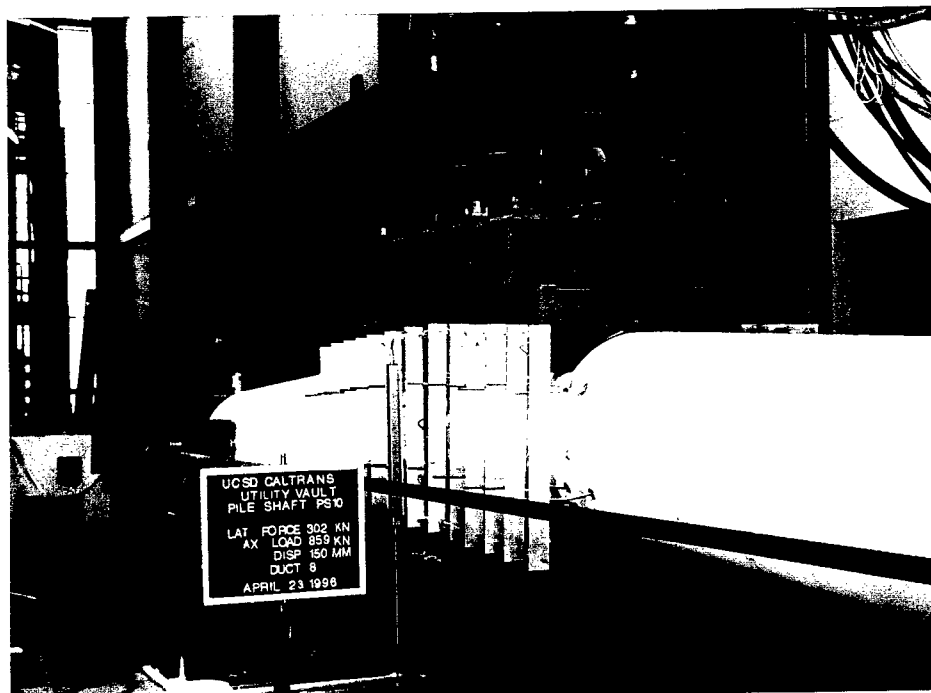
Fig. 5.4.1: Prestressed pile shaft test unit PS10 at $\mu=8$

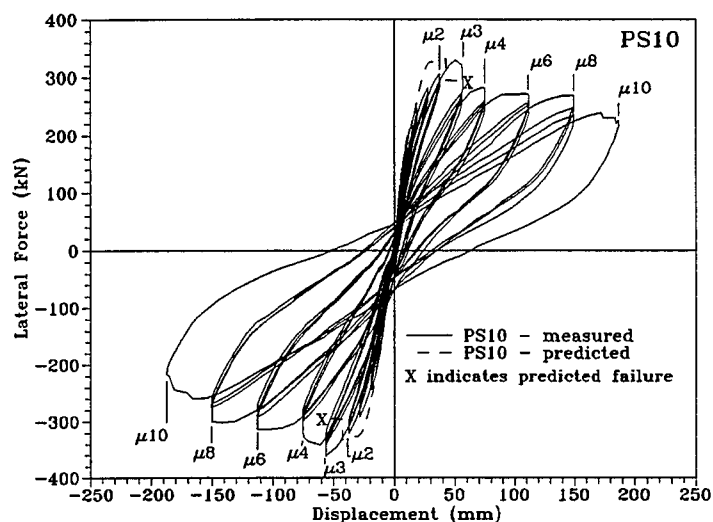
Fig. 5.4.3: Force-displacement hysteresis loops for pile shaft test unit PS10

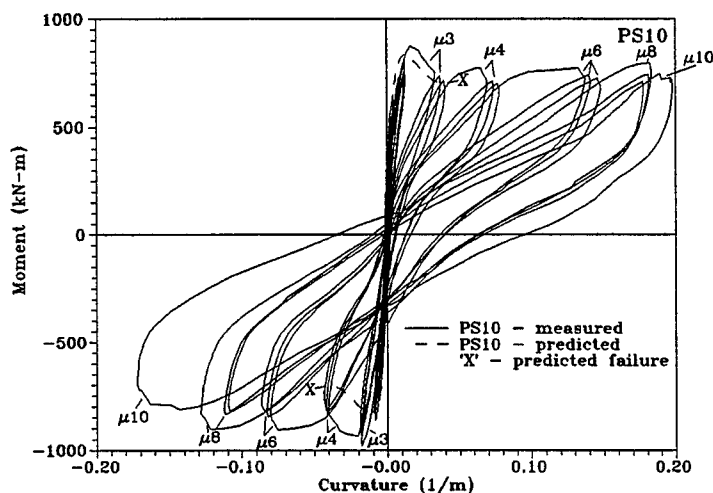
Fig. 5.4.4: Moment-curvature hysteresis loops about test unit midpoint, prestressed pile shaft test unit PS10

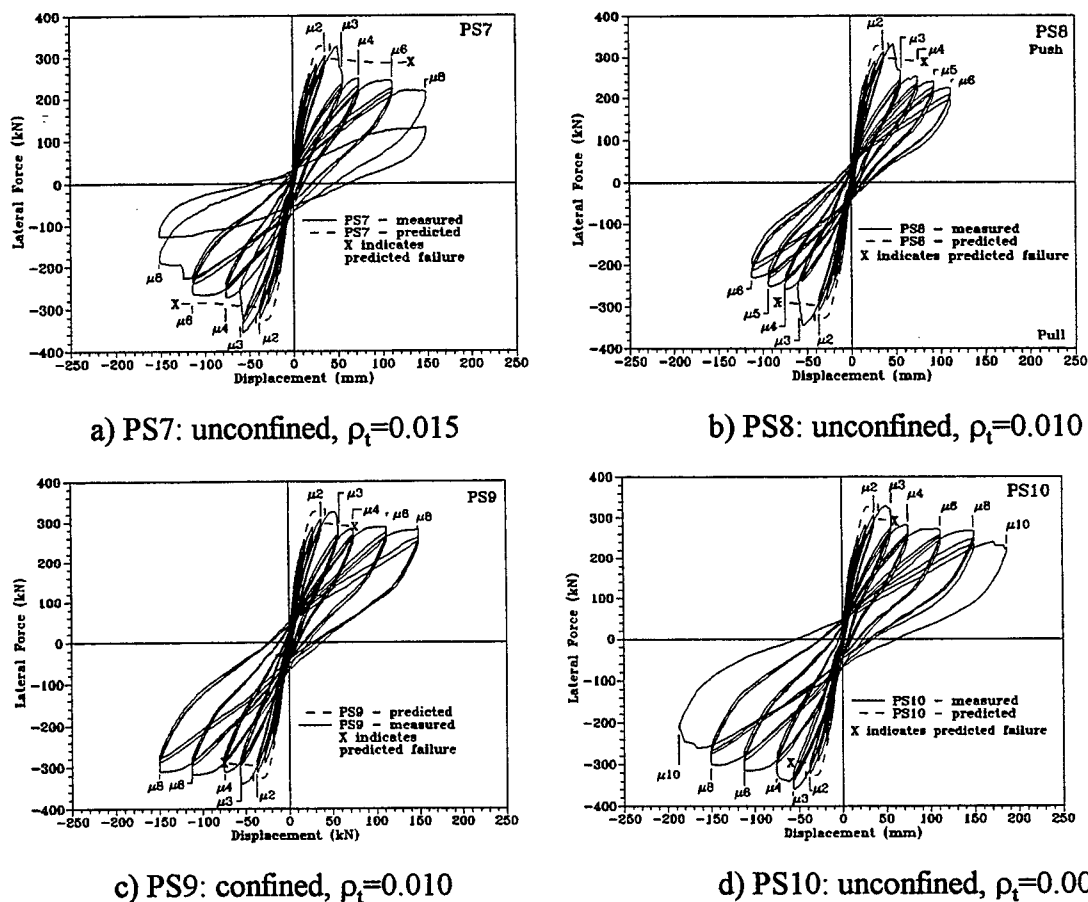
Fig. 5.5.1: Comparison of force-displacement hysteresis loops for prestressed pile shaft test units PS7 - PS10

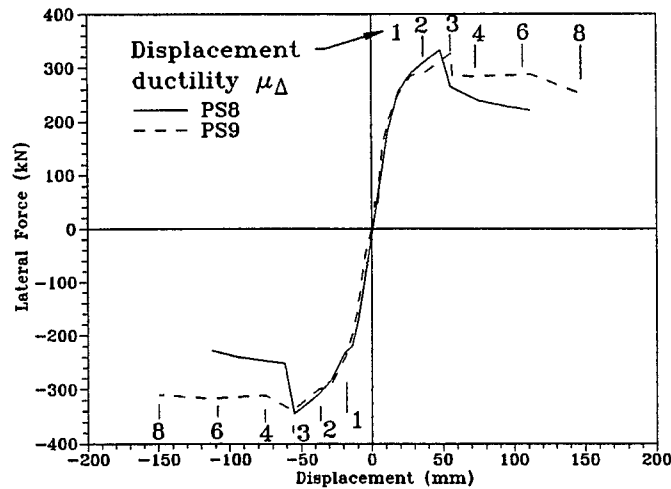
Fig. 5.5.4: Force-displacement envelopes for PS8 ($\rho_t=0.010$) and PS9 ($\rho_t=0.010$); PS8 with no external confinement about plastic hinge, PS9 with external confinement

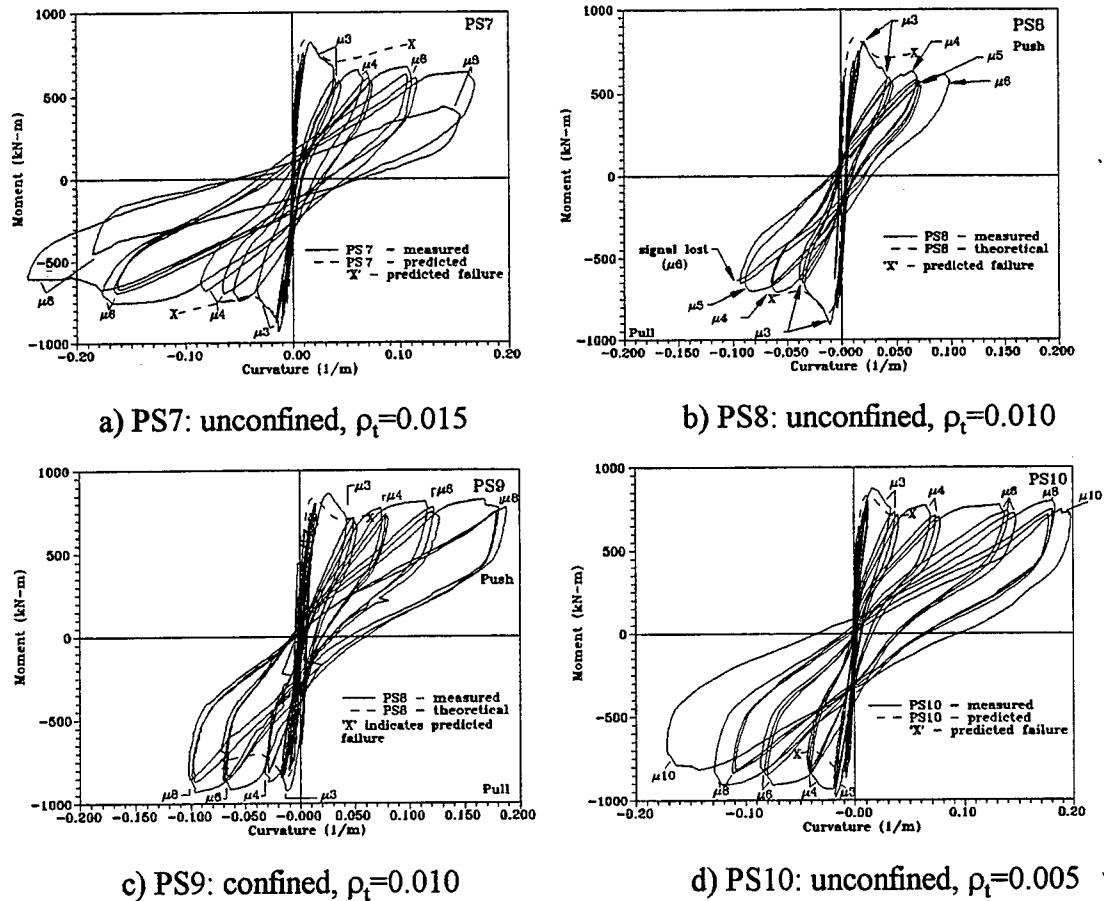
Fig. 5.5.6: Comparison of moment-curvature hysteresis loops for prestressed pile shaft test units PS7 - PS10

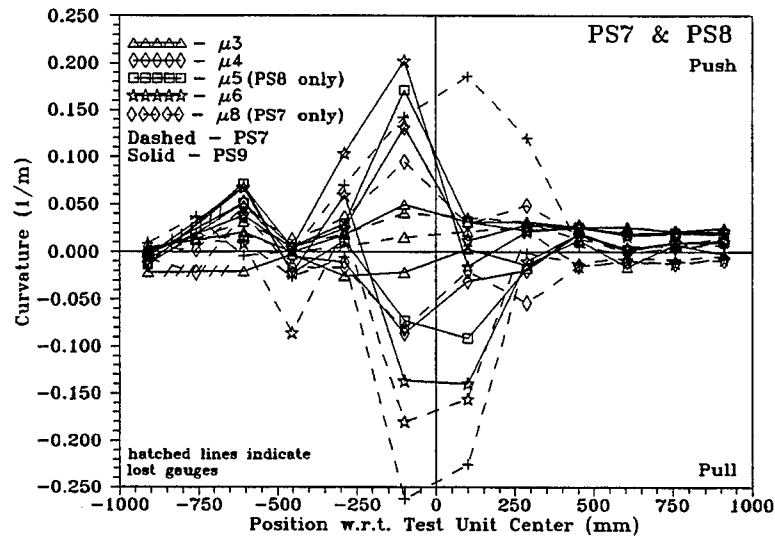
Fig. 5.5.7: Curvature profiles, PS7 ($\rho_t=0.015$) and PS8 ($\rho_t=0.010$); no external confinement

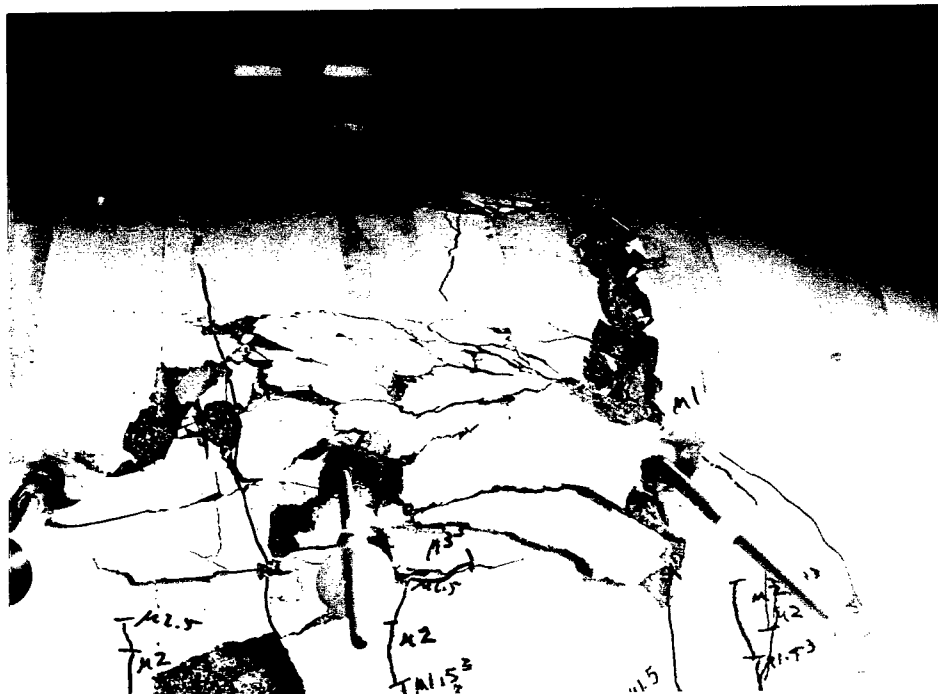
Fig. 6.1.1: Push-cycle compression zone of PS11 after removal of fixturing (heavy reinforcement, plastic hinge confined)

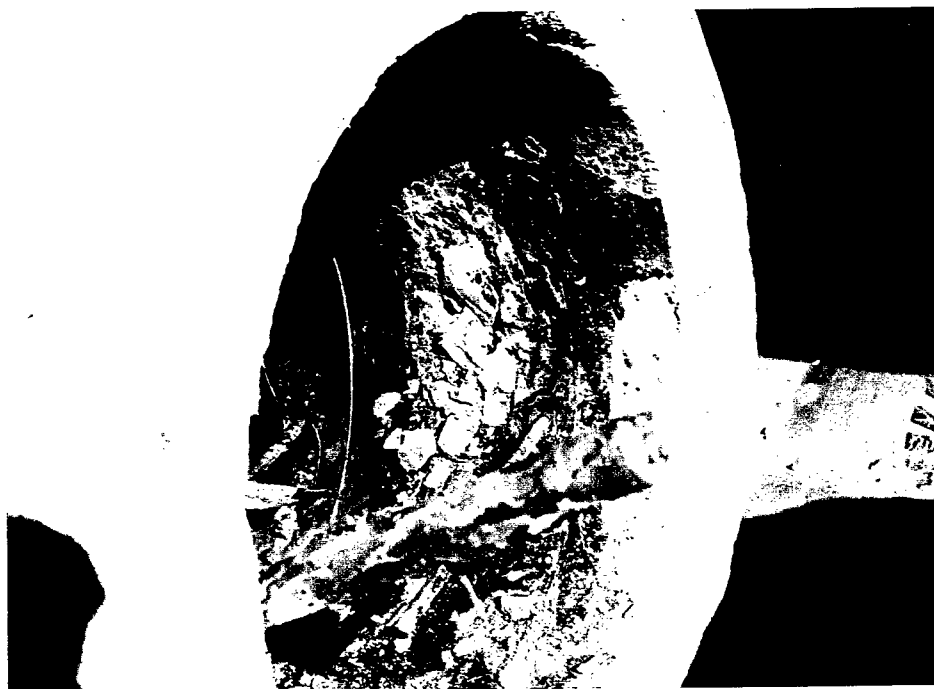
Fig. 6.1.2: PS11 after sectioning, showing spalled area of core face (heavy reinforcement, plastic hinge confined)

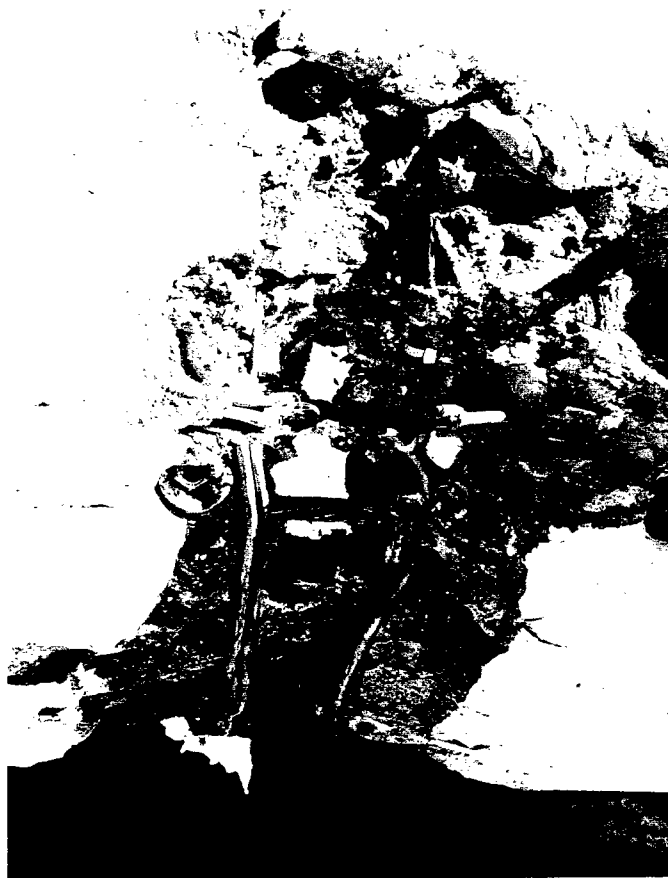
Fig. 6.1.3: The spalled cover of PS11 could be easily removed, showing that the damage went all the way through the shell (heavy reinforcement, plastic hinge confined)

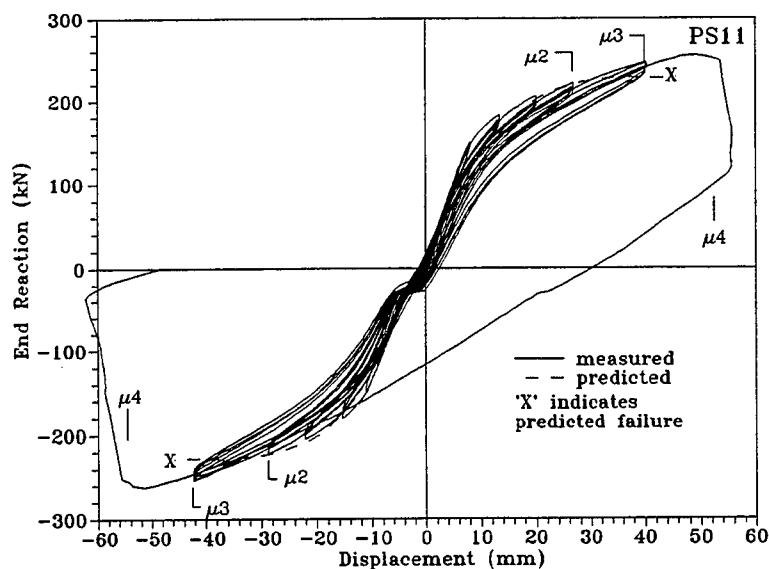
Fig. 6.1.4: Force-deflection hysteresis loops for hollow pile shaft test unit PS11 (heavy reinforcement, plastic hinge confined)

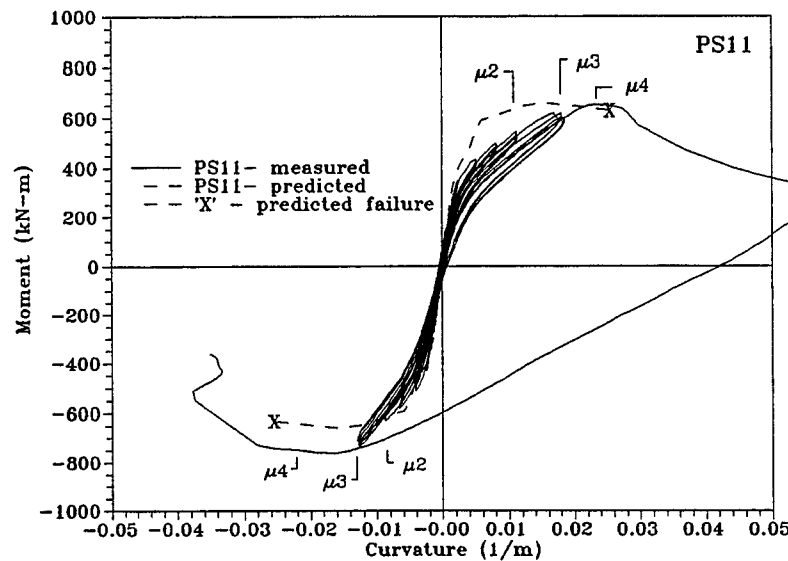
Fig. 6.1.6: Moment-curvature hysteresis loops at longitudinal midpoint, hollow pile PS11 (heavy reinforcement, plastic hinge confined)

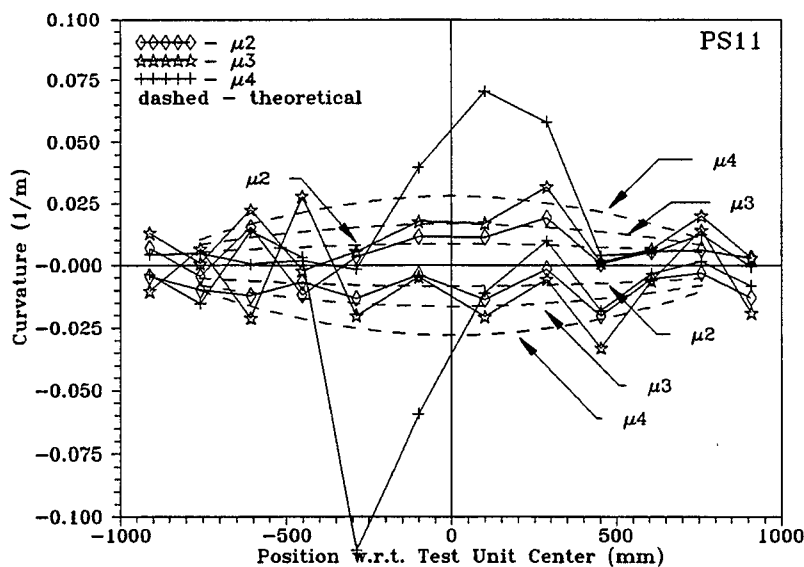
Fig. 6.1.7: Curvature profiles, hollow pile PS11 (heavy reinforcement, plastic hinge confined)

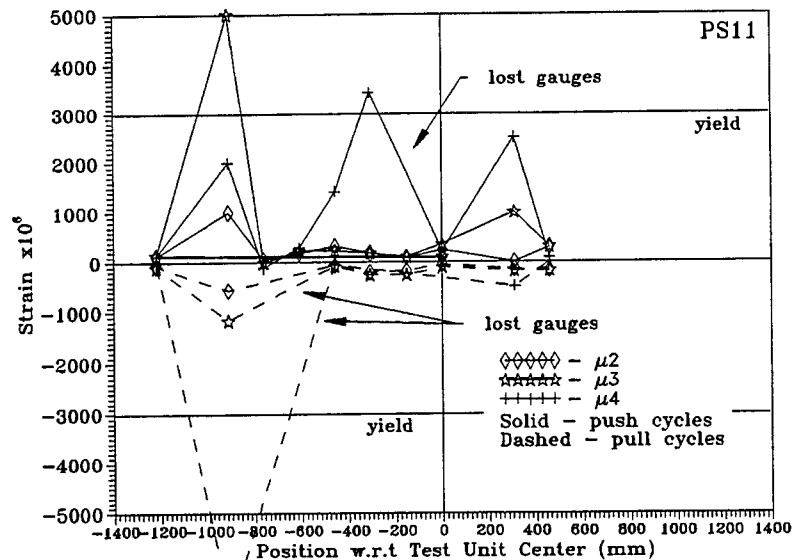
Fig. 6.1.8: Confining steel strain, hollow pile test unit PS11 (plastic hinge confined, heavy reinforcement)

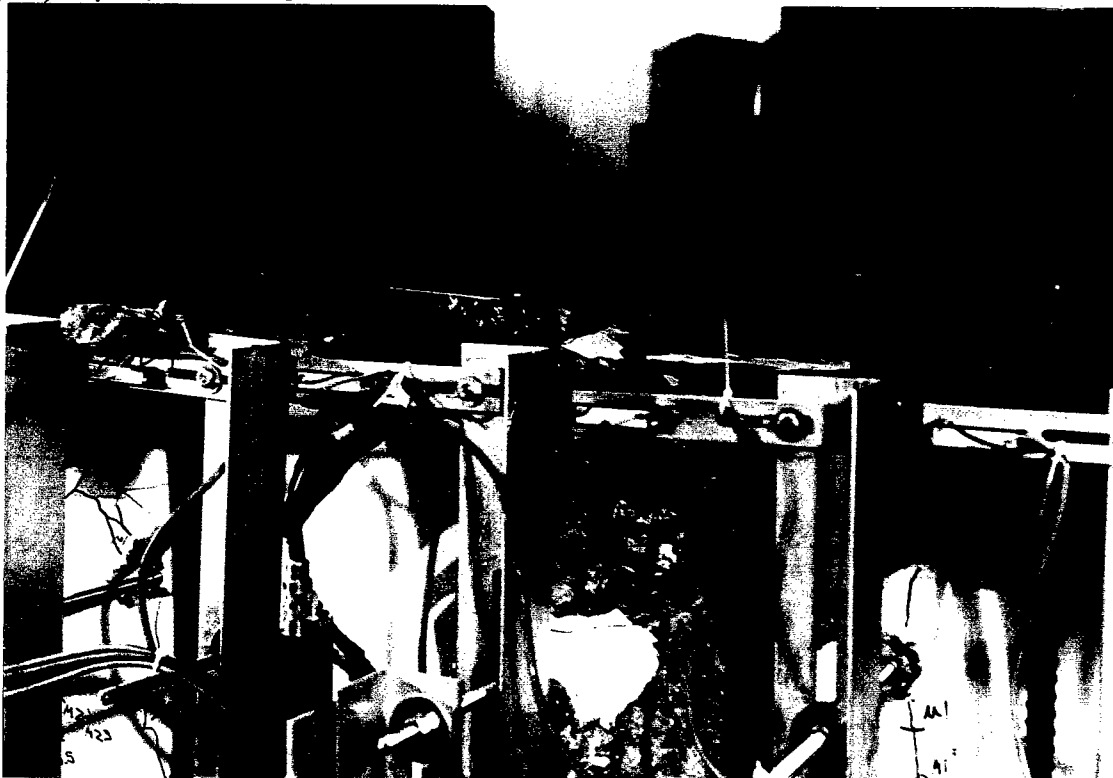
Fig. 6.2.1: Hollow pile PS12, compression zone failure (medium reinforcement, plastic hinge unconfined)
